# TECHNICAL FEATURE

## WHAT WENT WRONG: A CASE STUDY

The installation of a quarter panel on a 2010 BMW 328xi seems like an easy job, right? Maybe not. In this month's article, we will look at a case study of a vehicle repair that went very wrong.

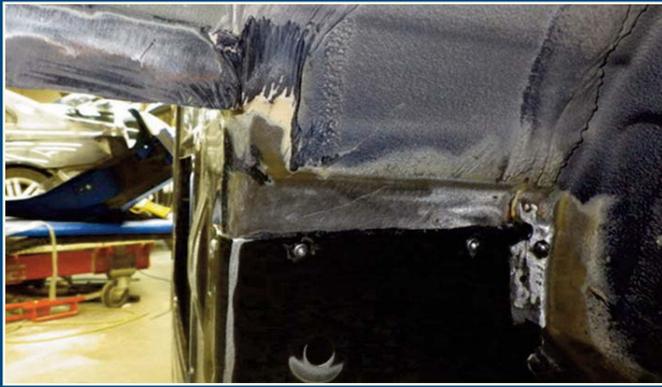
**Right rear quarter panel:** Multiple exposed Metal Active Gas (MAG) plug welds with indications of burn-through on the inner quarter panel brace mating flanges were observed. Indications of bare metal areas with corrosion and tool-type impact markings to the rear area of the outer wheelwell housing were observed. Also noted was excessive corrosion to the outer wheelwell wheel lip mating flange, and multiple incomplete MAG plug welds, suggesting lack of penetration from the inner quarter panel brace to inner wheelhouse panel. Multiple indications of incomplete weld fusion of the squeeze-type resistance spot welds (STRSW) were observed on the quarter panel to inner wheelhouse panel at the door opening mating flange and backlit mating flange areas. The inner flange area showed evidence of burned paint material, supporting that the flange was not properly prepared prior to welding. Additionally, no evidence of any corrosion protection and/or rust-proofing compound applications was observed to the enclosed areas and flanges.

Right wheel house to 1/4 extension: MAG plug welds present, requires rivet-bond procedure.

The replacement rear body panel and right rear quarter panel were installed utilizing MAG welds and STRSW, although BMW of North America specifically requires panels to be installed with rivets and structural adhesives (rivet bonding). Multiple areas were observed with missing and/or improperly applied seam sealer. The repairs performed on the BMW from the incident of March 19, 2012 show evidence to support a direct relationship to the water intrusion to the battery tray/quarter extension panel.

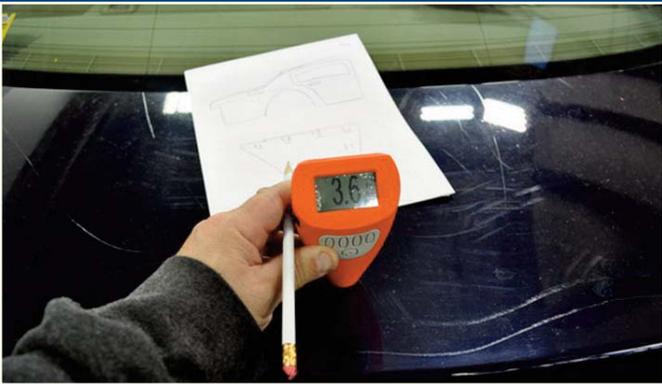
Film thickness measurement of new deck lid, 3.6mils. Slightly thin coating.

Paint film thickness readings varied on the panels and were inconsistent. On new panels, readings ranged from 2.4mils to 3.2mils, suggesting not enough material application. On repaired panels, readings ranged from 4.2 mils to 8.8mils, suggesting too much material application.

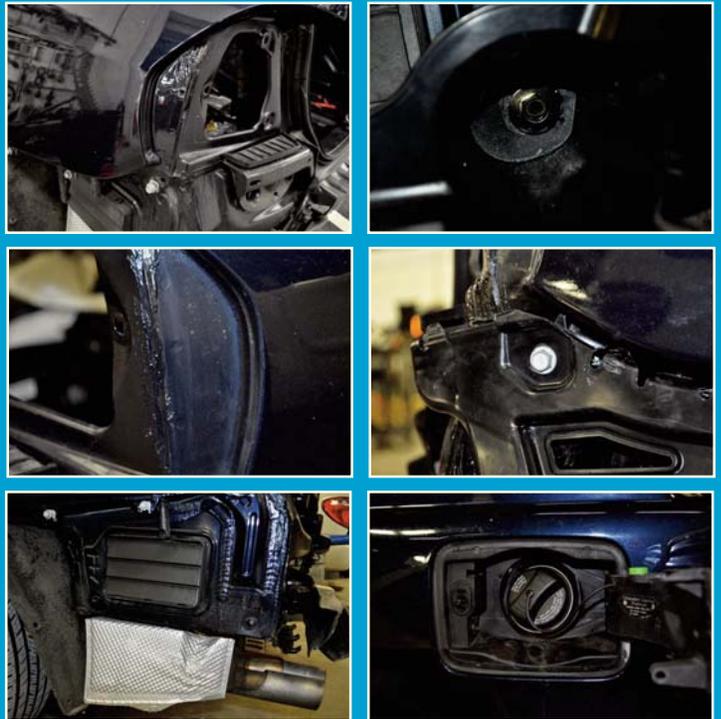
**Right bumper mounting bracket (plastic):** Nutserts were installed in the two lower mounting areas on the right rear quarter extension panel, and two bolts were installed. BMW utilized coarse-threaded studs resistance welded onto the panel and attached the bracket with plastic nylon nuts. BMW does service the studs and has a part number. The application of butyl tape to the nutserts, in an attempt to prevent water intrusion, was also noted.

**Fuel pocket:** The pocket assembly was loose and the fuel door lock assembly lower clip was fractured and glued. Removal of the fuel pocket requires replacement, due to the four corner clips that must be damaged to remove it.

Clockwise from top left: Left side tail lamp pocket panel to left rear quarter panel, OEM Original; Bolt installed with butyl on right bumper side mounting bracket instead of a resistance welded stud; Bolt installed with butyl on right bumper side mounting bracket instead of a resistance welded stud; Fuel pocket with missing clips; Left side quarter panel to quarter extension panel, OEM untouched; Right tail lamp to quarter panel flange, seam open.
