The Importance of Collision Photography

By Larry Montanez III, CDA and Jeff Lange, PE

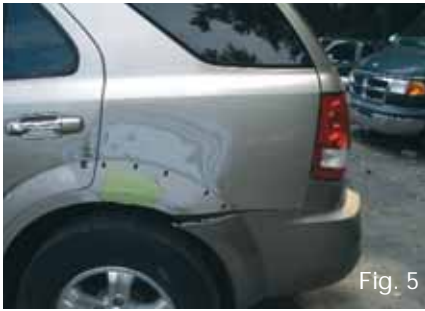
To assist you in the proof of the amount of labor time required to repair that area, take photos of the sanded area with bare metal showing and/or dent removal pins attached. This will assist in showing the extent of damage and sometimes the amount of work that went into the repair (Fig. 5). Photos of vehicles masked off in the spray booth are another important set of photos, which will show evidence of what was painted and blended.
