BLENDING AND “UP AND OVER:” WHAT’S THE TRUTH?

TECHNICAL FEATURE

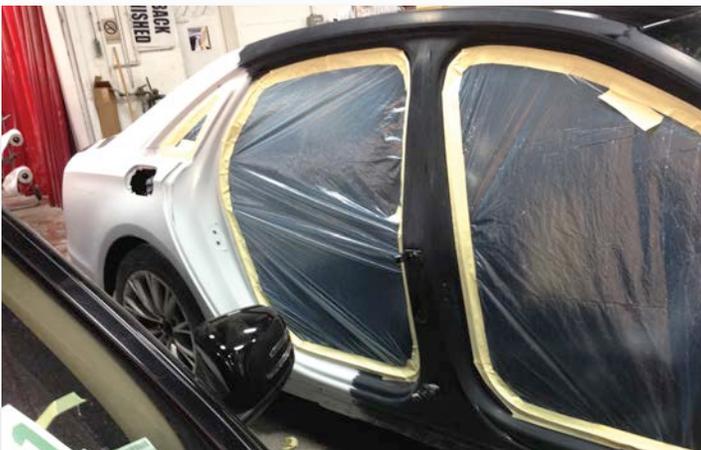
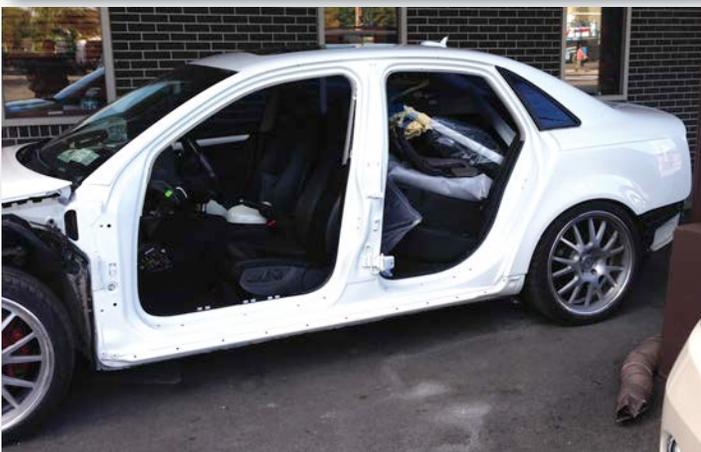
These photos are a good example of damage only to the quarter panel. These two vehicles are at a certified repair facility. Notice that the doors and fenders are off.

Considering that our example is a continuous/uniside panel vehicle, performing the refinish repair properly and keeping the paint manufacturer’s warranty would require the repair facility to remove both front door assemblies, windshield, backlite, both quarter panel glasses, deck lid and adjacent trim components. Surprisingly, the damage report was more than 90 lines of procedures with approximately 40 hours of labor and 19 hours of refinishing. See the estimate for more details. Please note that a Labor Rate of \$50 was only used as an example and in no way is meant to suggest a rate for repairs. Pretty surprising the amount of procedures that are required for a one-hour scratch to the left rear quarter panel!
